**Specific Site Assessment for
Coal Combustion Waste
Impoundments at Duke Energy
Carolinas Lee Steam Station**

Williamston, South Carolina

GEI Consultants, Inc.
4601 DTC Blvd., Suite 900
Denver, CO 80237

July 2010
Project 092881

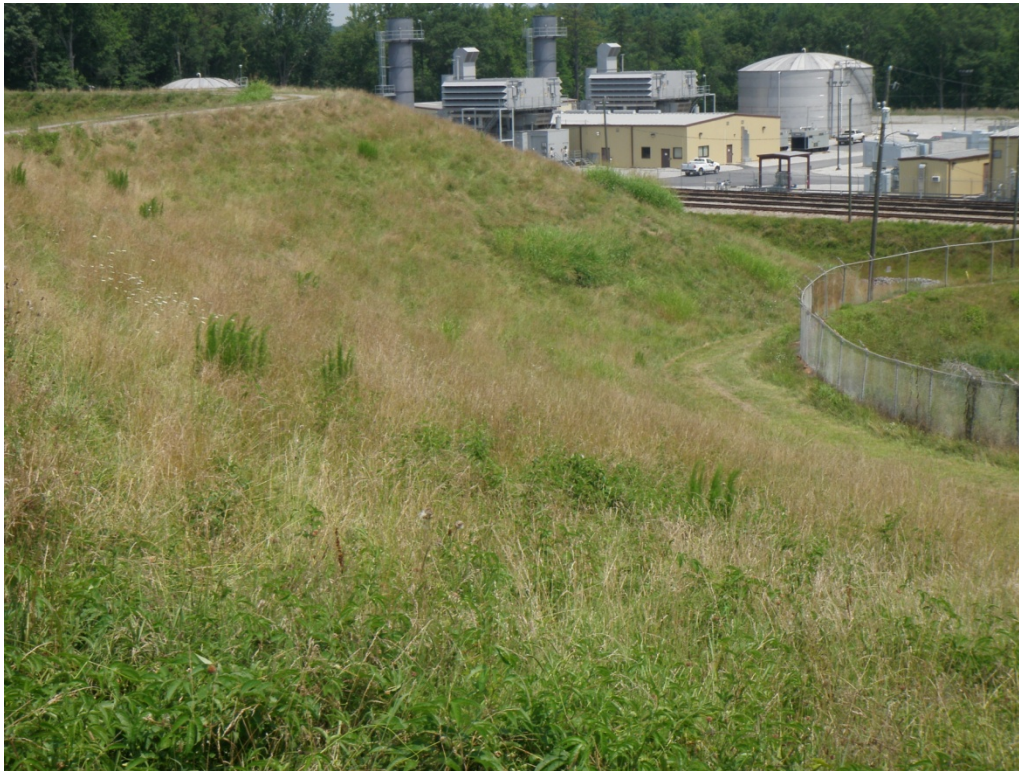
Photo 1 – Primary Active Ash Pond Dam : Downstream slope near right abutment.

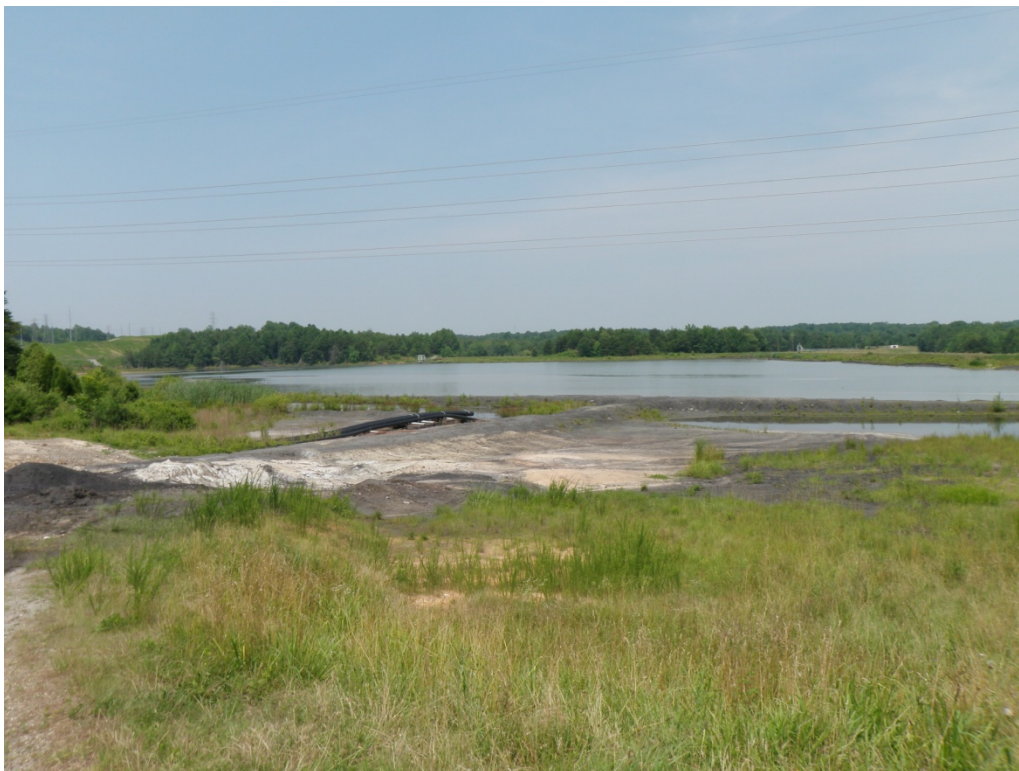
Photo 2 – Primary Active Ash Pond Dam: Overview from right abutment.

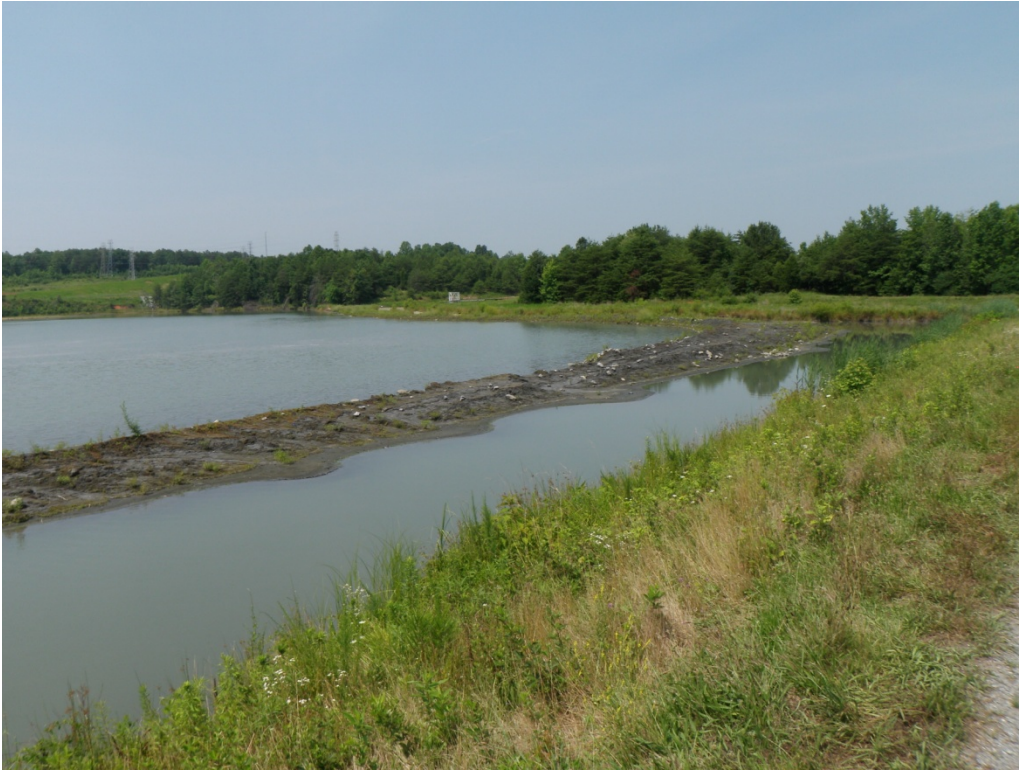
Photo 3 – Primary Active Ash Pond Dam: upstream slope and channel to decant pipe (looking west).

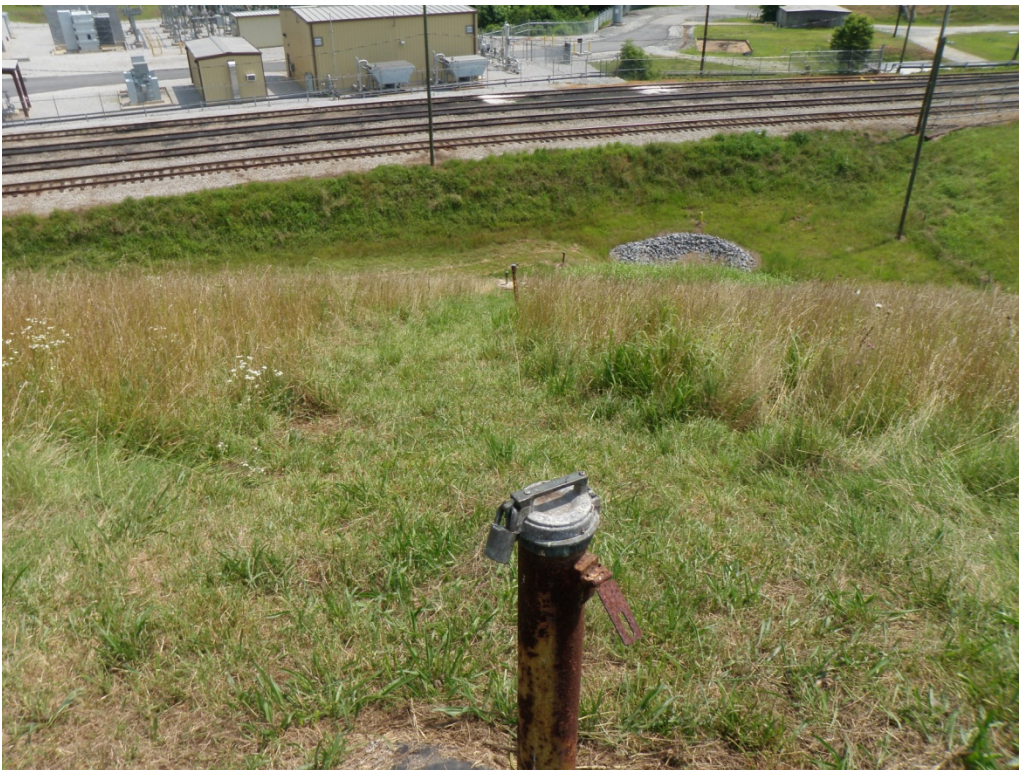
The water levels in piezometers L-1, L-2 and L-3, near the left abutment of the Primary Active Ash Pond dam, have remained relatively steady with time. The water level in piezometer L-3, at the dam toe, rose 6 to 7 feet in December 2005 and February 2010, but returned back to consistent levels in subsequent readings. The cause for these erratic readings is unknown.

Photo 4 – Primary Active Ash Pond Dam: Piezometers L-1, L-2 and L-3 and toe drain inlet.

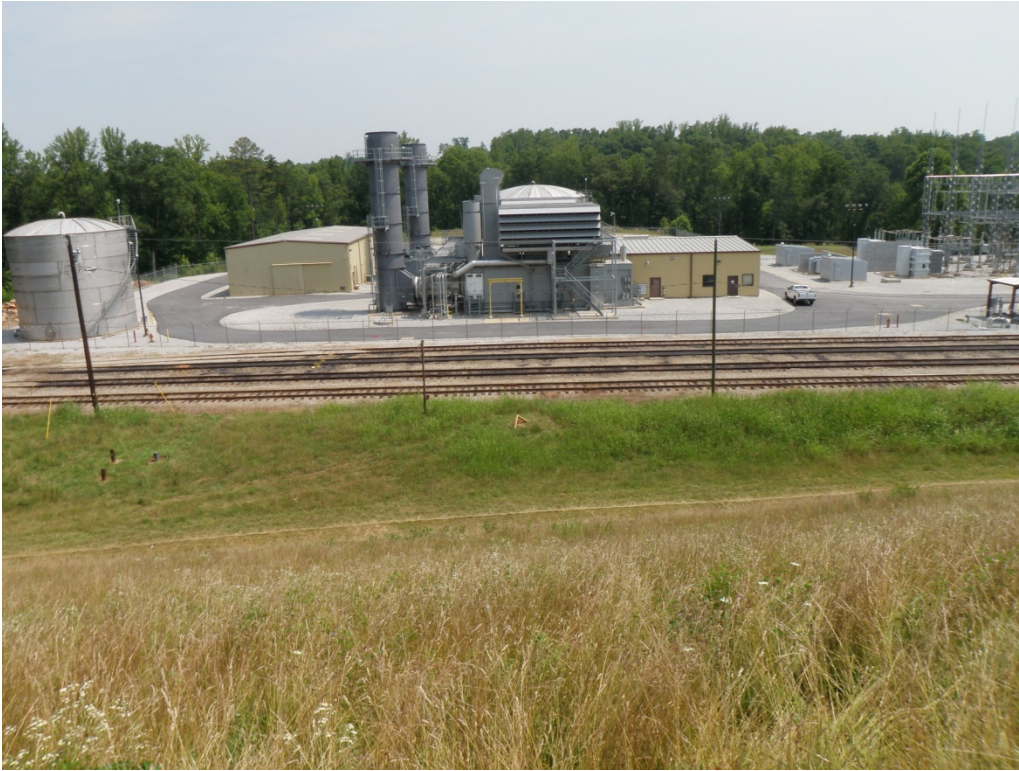
Photo 5 – Primary Active Ash Pond Dam: Plant buildings downstream.

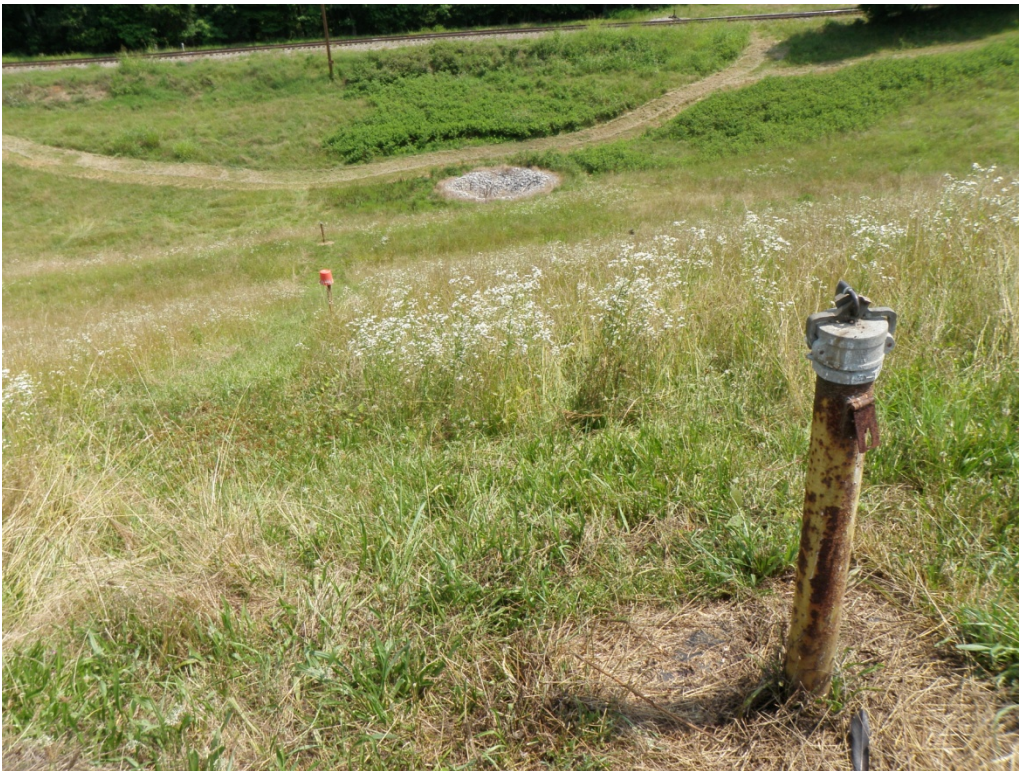
between December 2009 and April 2010 it rose about 17 feet. In April 2010 the water fell back to within several feet of its previous levels. The cause for the sudden rise in water level in piezometer L-4 is unknown.

Photo 6 – Primary Active Ash Pond Dam: Piezometers L-4, L-5 and L-6 and toe drain inlet.

5. The water level in piezometer L-4 began rising in October 2009, and was elevated until April 2010. The cause of the elevated water level should be investigated and corrected if necessary, and analyses should be performed to evaluate whether an elevated water level in the vicinity of L-4 could potentially compromise the safety of the Primary Ash Pond Dam.

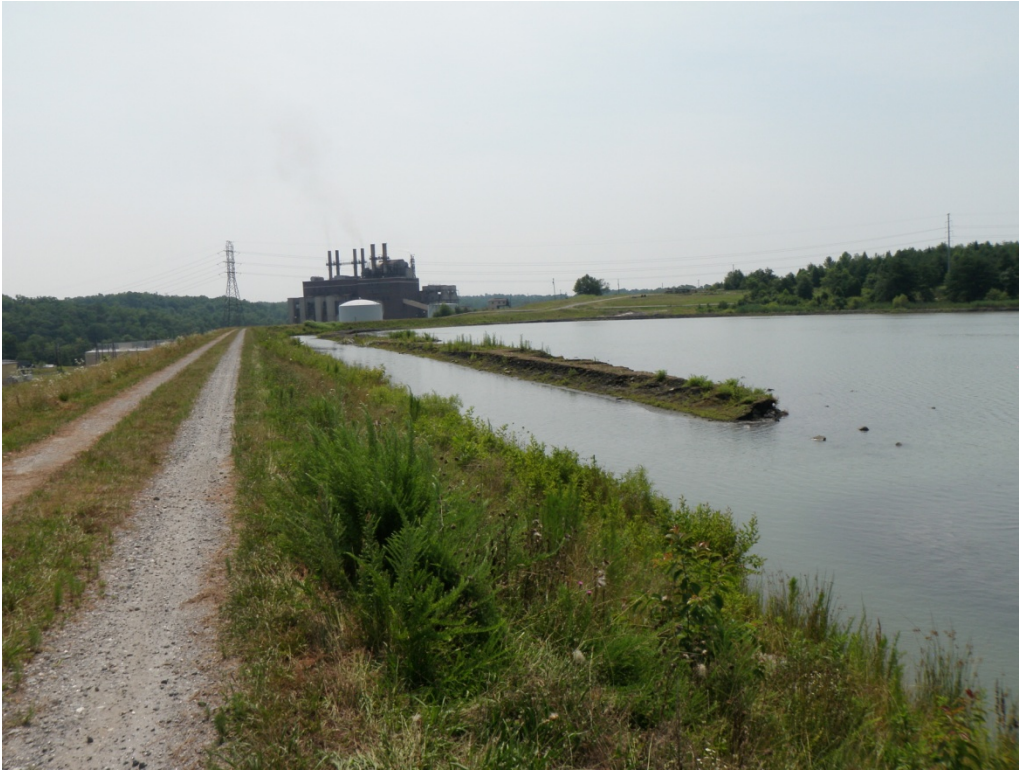
Photo 7 – Primary Active Ash Pond Dam: Upstream face and channel to decant pipe (looking east).

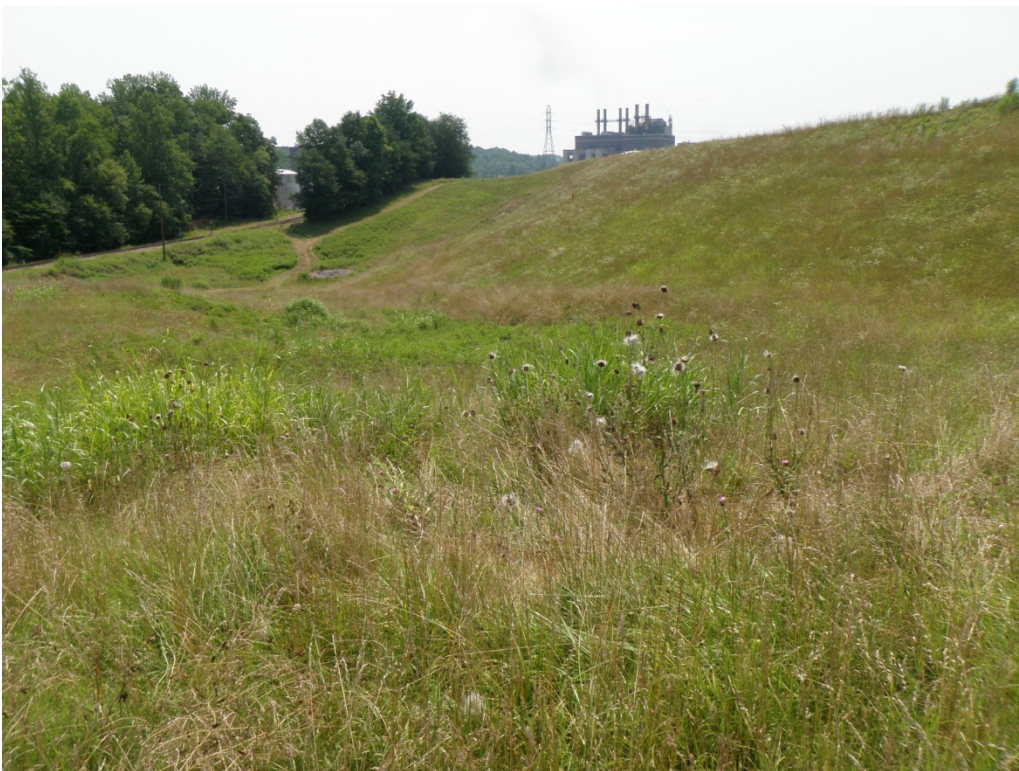
Photo 8 – Primary Active Ash Pond Dam: downstream face from left abutment.

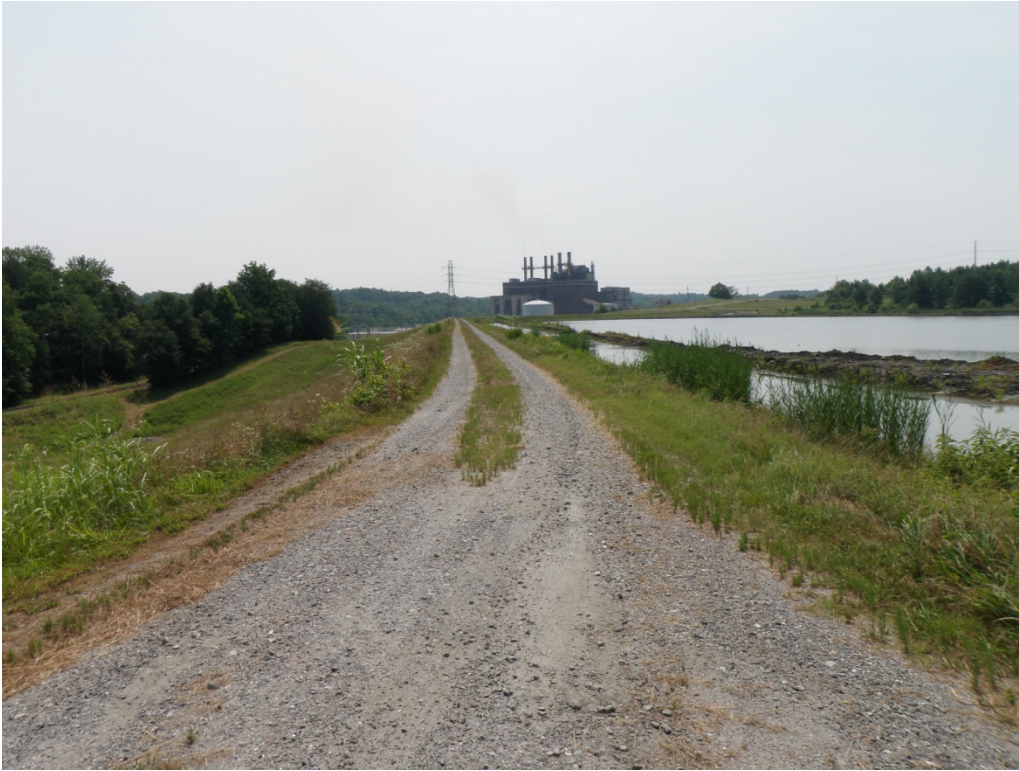
Photo 9 – Primary Active Ash Pond Dam: Crest from left abutment.

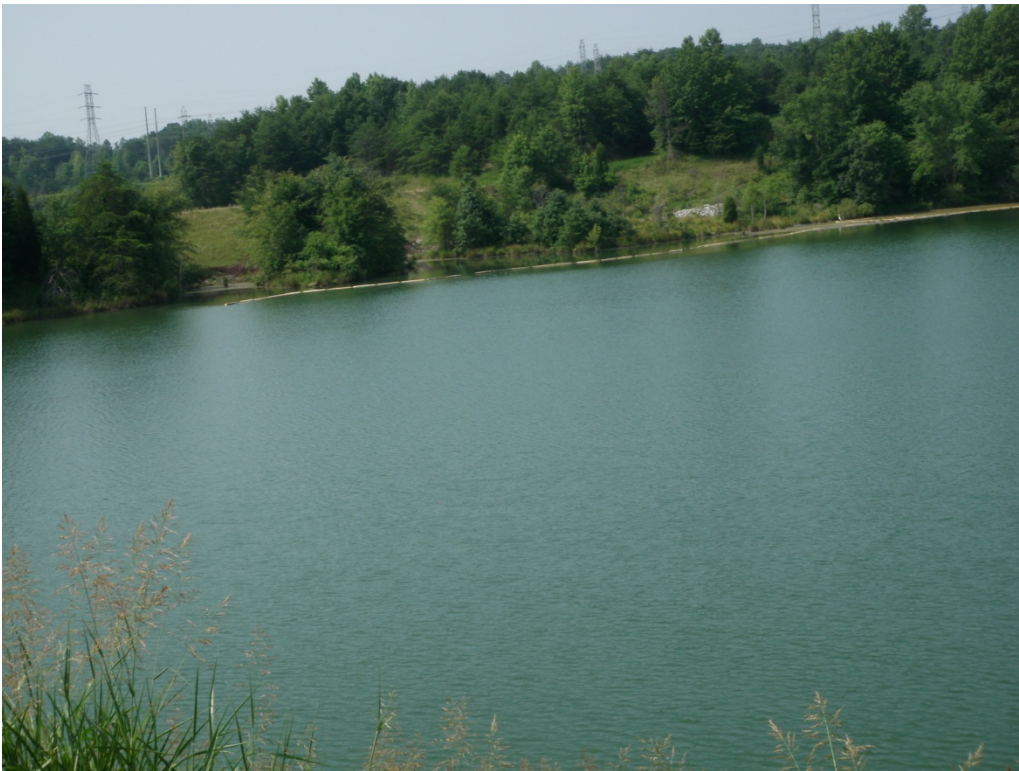
Photo 10 – Secondary Ash Basin: Looking across pond to divider dike.

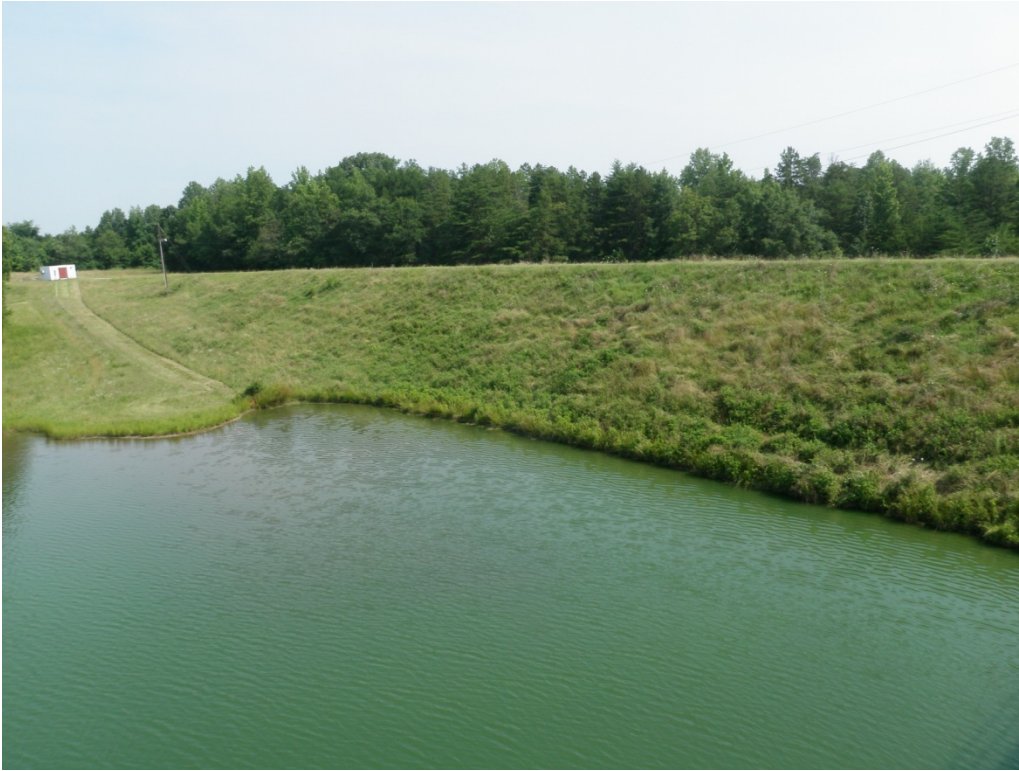
Photo 11 – Secondary Ash Basin Dam: Upstream slope and left abutment.

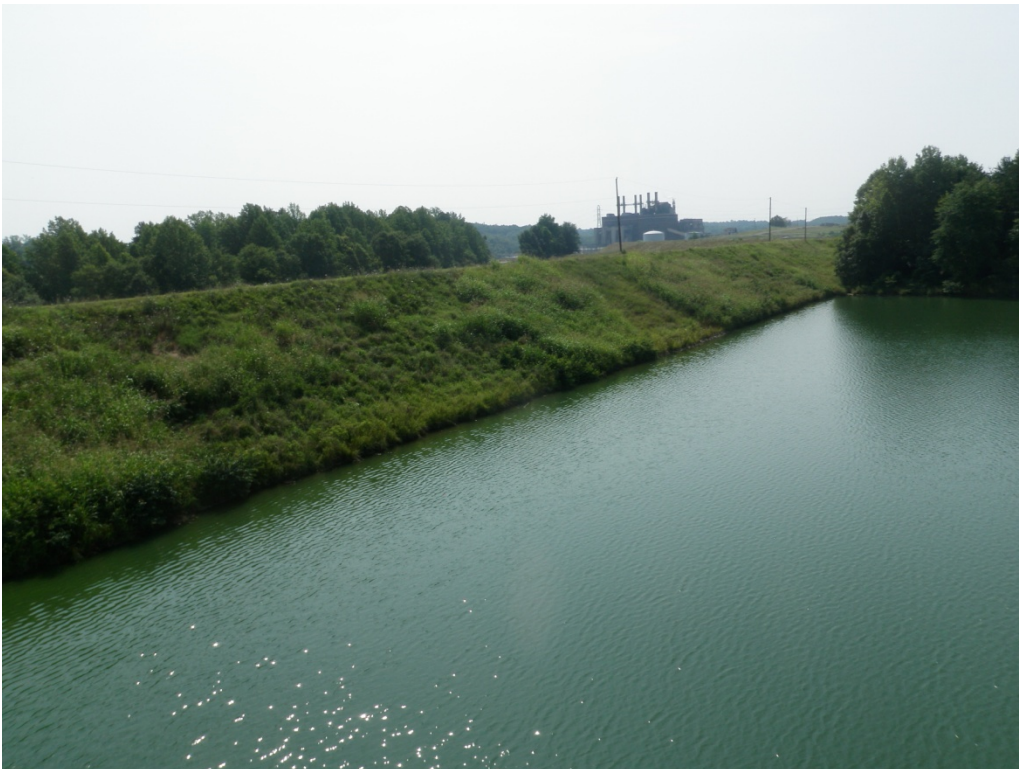
Photo 12 – Secondary Ash Basin Dam: Upstream slope looking toward right abutment.

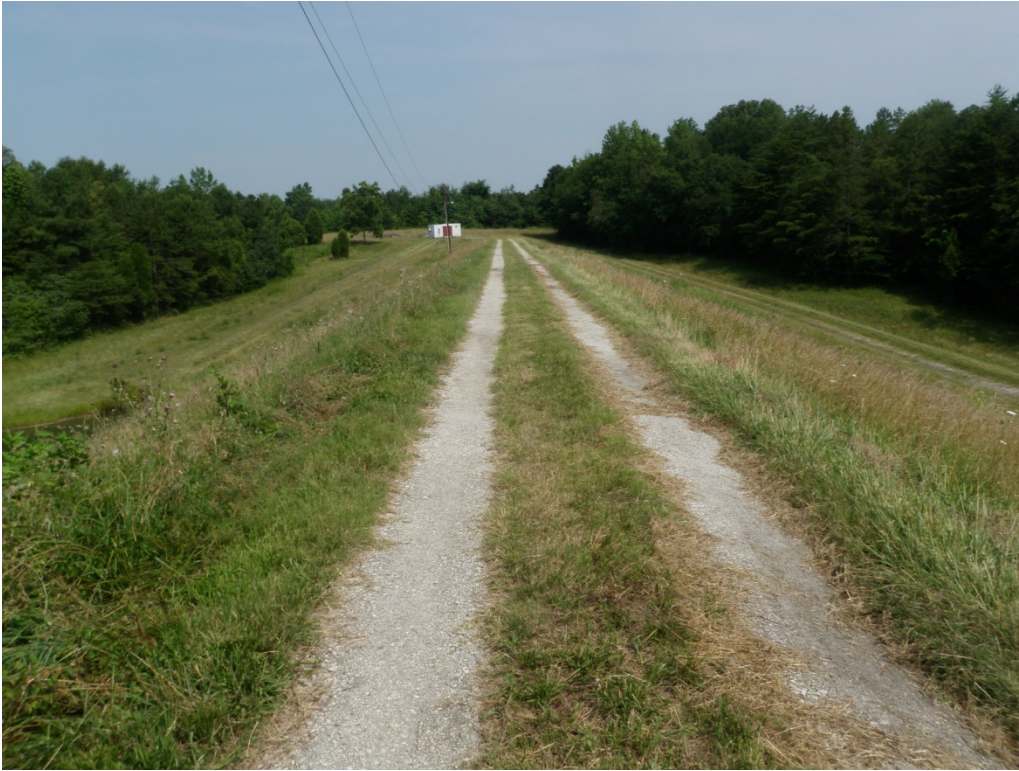
Photo 13 – Secondary Ash Basin Dam: Crest, looking west.

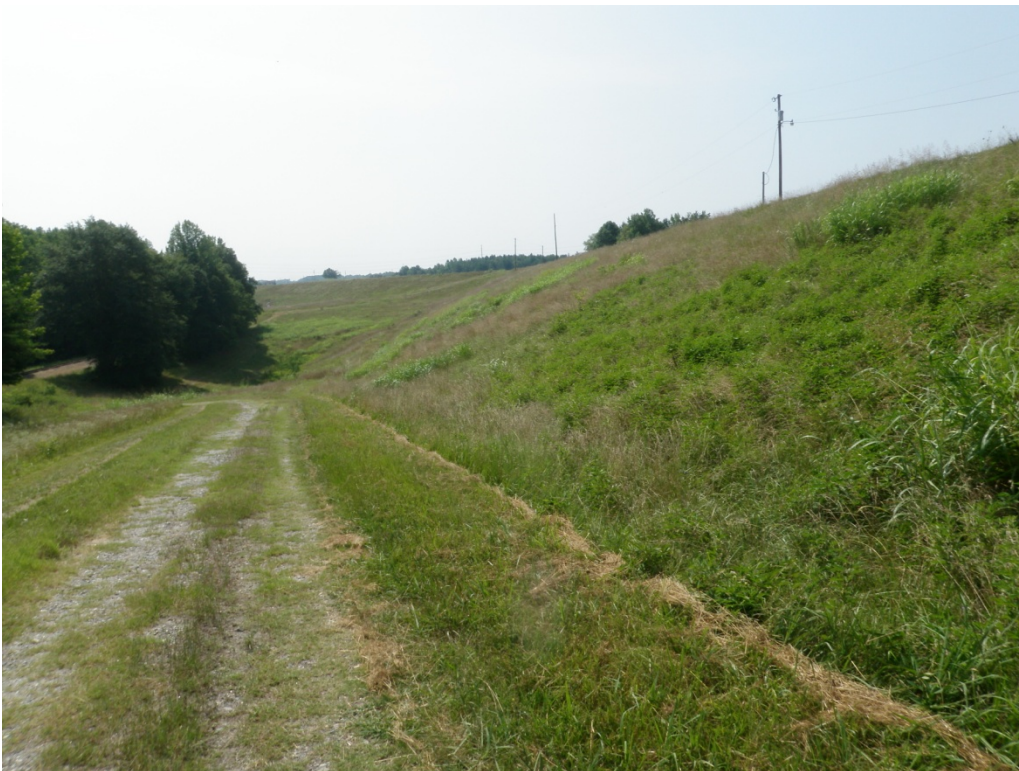
Photo 14 – Secondary Ash Basin Dam: Downstream slope from left abutment.

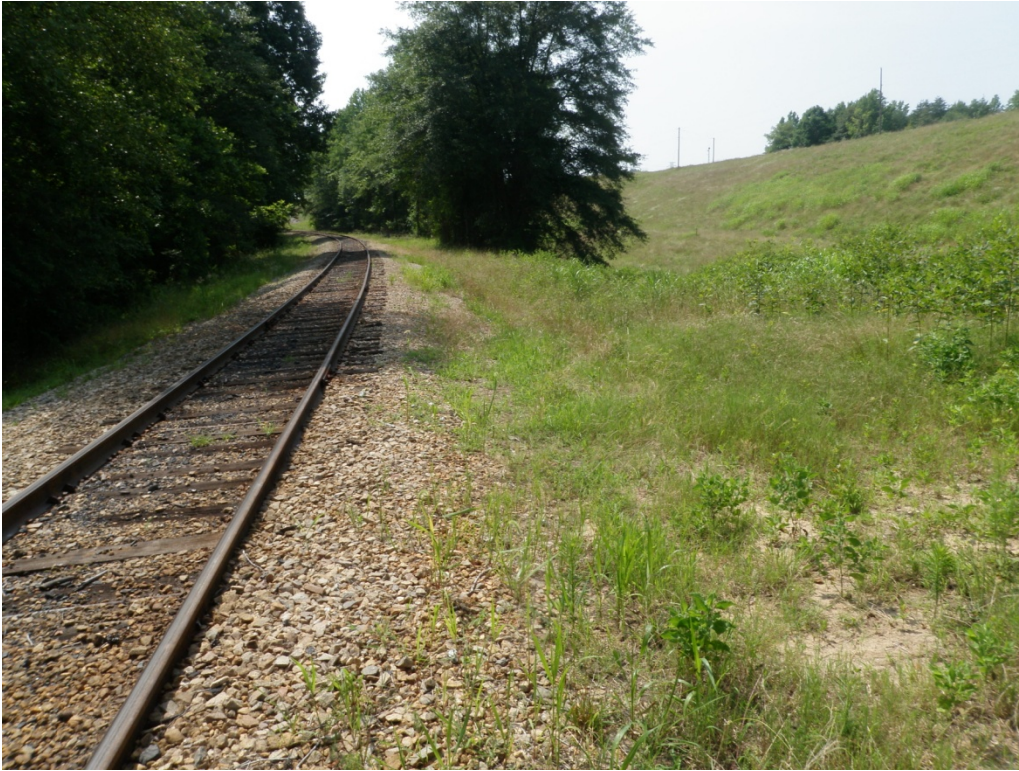
Photo 15 – Secondary Ash Basin Dam: Railroad embankment downstream of toe.

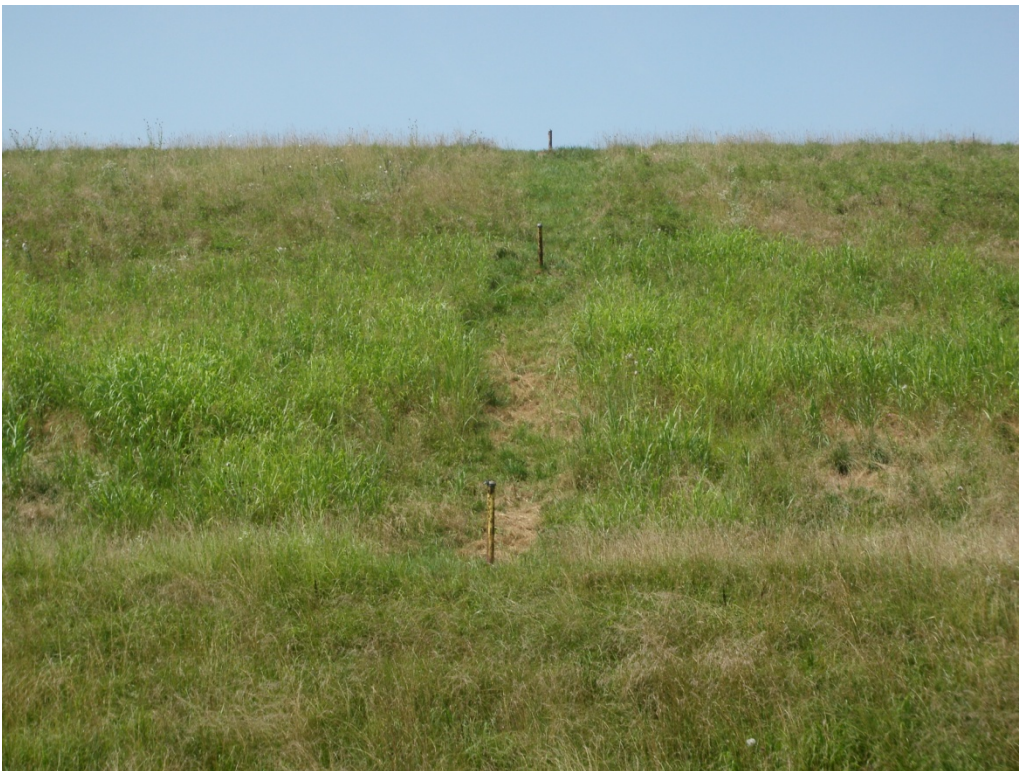
Photo 16 – Secondary Ash Basin Dam: Piezometers L-7, L-8 and L-9.

3. The liquefaction potential of the sandy silt comprising the embankment fill and the foundation should be evaluated.
4. The water level in piezometer L-9, near the toe of the Secondary Ash Basin dam, is about ten feet higher than the water levels in the piezometers at the toe of the Primary Active Ash Pond dam, and is higher than the piezometric surface assumed at this location in the stability analyses performed in 1984. The elevated water level may be caused by the seepage downstream of the right abutment of the Secondary Ash Basin dam, and may indicate that the toe drain in this area is not functioning properly. Stability analyses should specifically investigate whether the elevated water level in this area could compromise the stability of the dam.

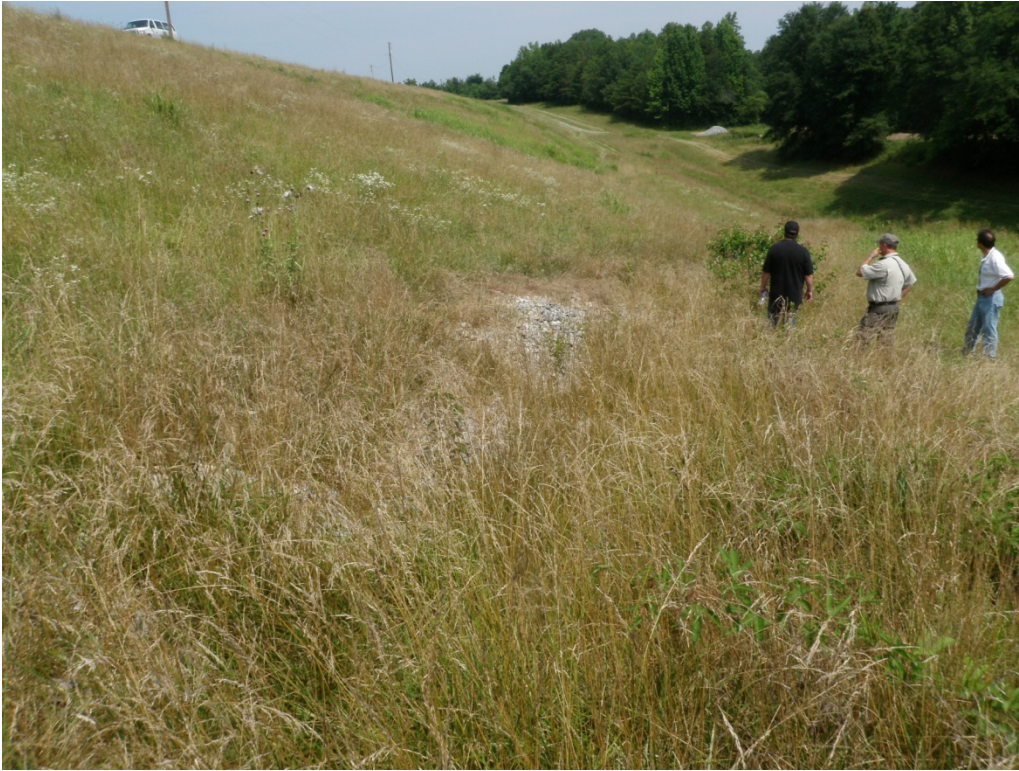
Photo 17 – Secondary Ash Basin Dam: Downstream face from left abutment. Note riprap along abutment contact.

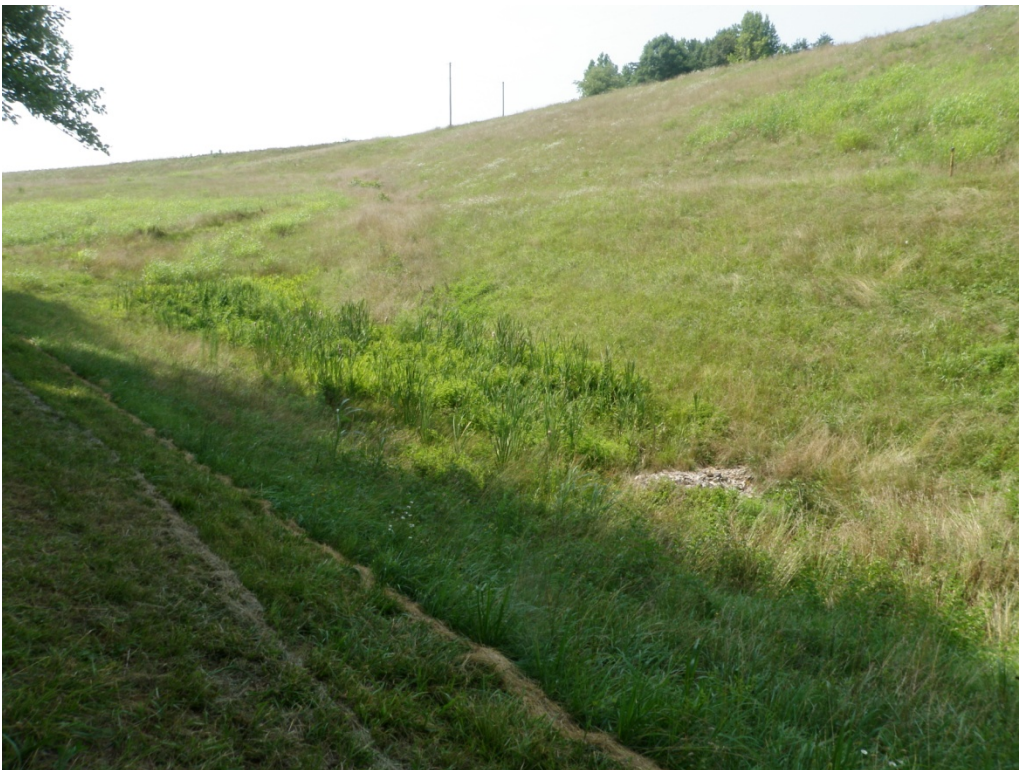
We observed a seepage area on the natural ground surface downstream of the right abutment of the Secondary Ash Basin dam, around El. 680. The ground surface in the seepage area is soft and wet, with flowing water in some areas. The flowing water was clear, and there were no boils, erosion or other signs of movement in the seepage area. Wetland-type vegetation was present in the seepage area. Duke Energy personnel indicated that there has been seepage in this area for at least 24 years, and that based on their visual monitoring, it has not increased, decreased or otherwise changed markedly over this time period. The seepage has never been measured or analyzed by Duke Energy. It is unknown whether the seepage originates from the Primary Active Ash Pond or the Secondary Ash Basin.

Photo 18 – Secondary Ash Basin Dam: Seepage area downstream of right abutment. Note vegetation.

1. We recommend formal monitoring and analysis of the seepage area downstream of the right abutment of the Secondary Ash Basin in order to evaluate whether seepage could potentially compromise the stability of the dam. Monitoring should include installation of a weir and grading to direct seepage toward the weir. The weir should then be monitored monthly in order to establish a baseline measurement of seepage quantity. Continued monitoring will then show whether the seepage quantity changes with time. In addition, we recommend measuring turbidity in the seepage. A large amount of fines in the seepage could indicate piping of material through the dam.

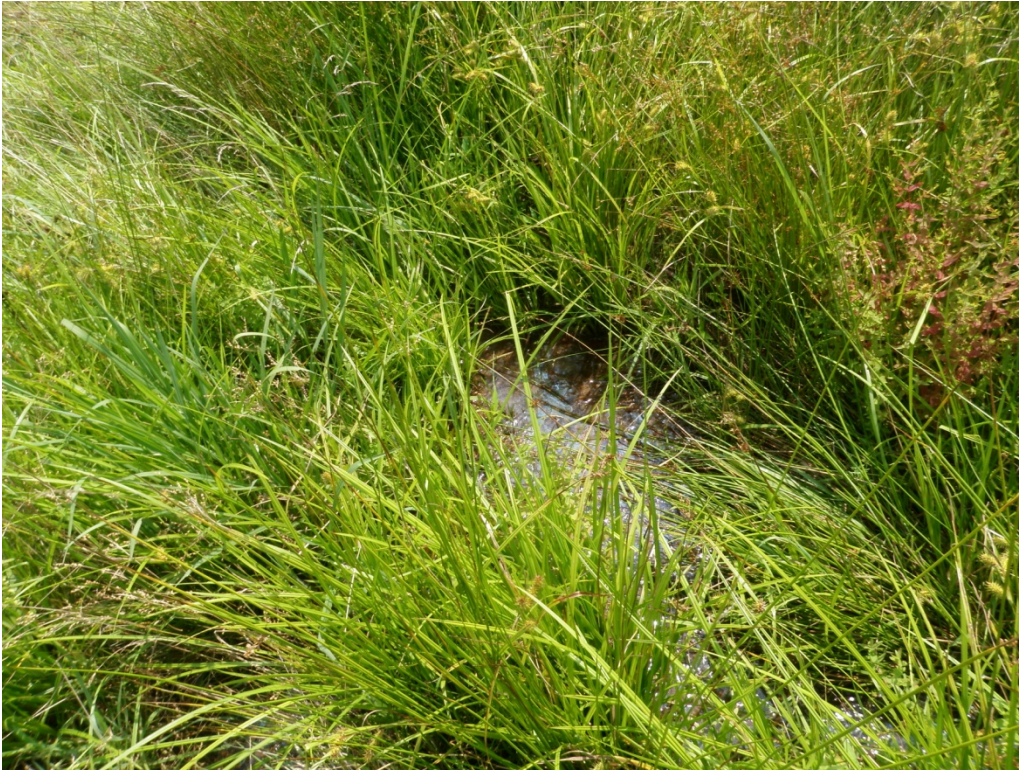
Photo 19 – Secondary Ash Basin Dam: Flowing water in seepage area.

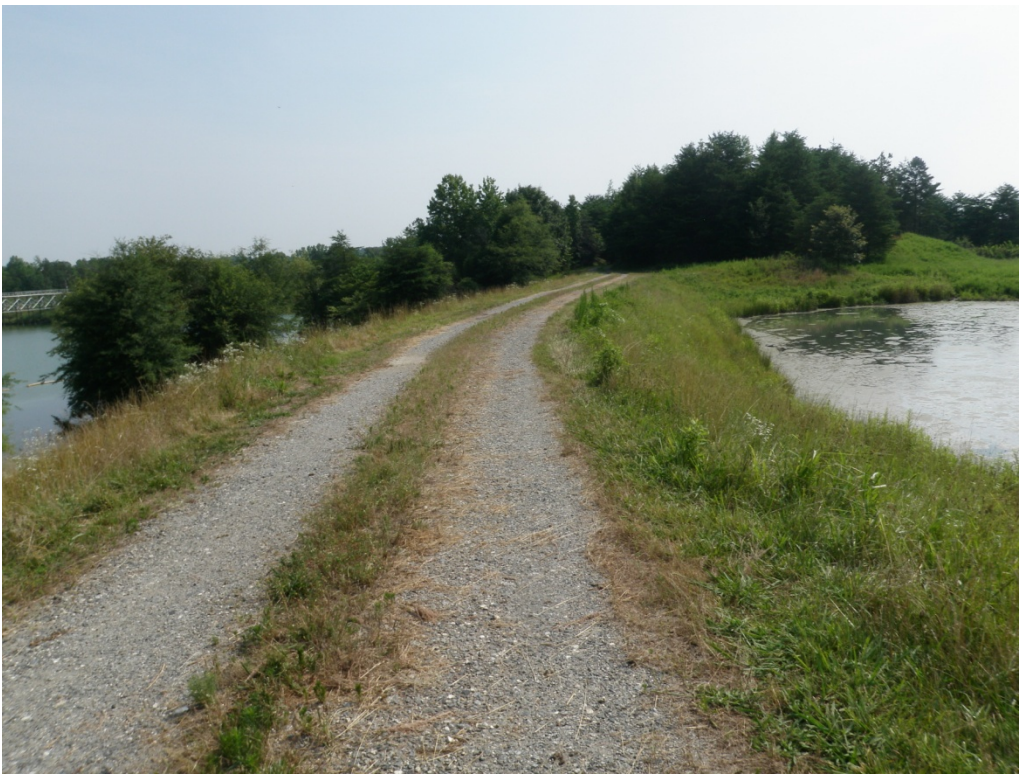
Photo 20- Divider Dike: Crest.

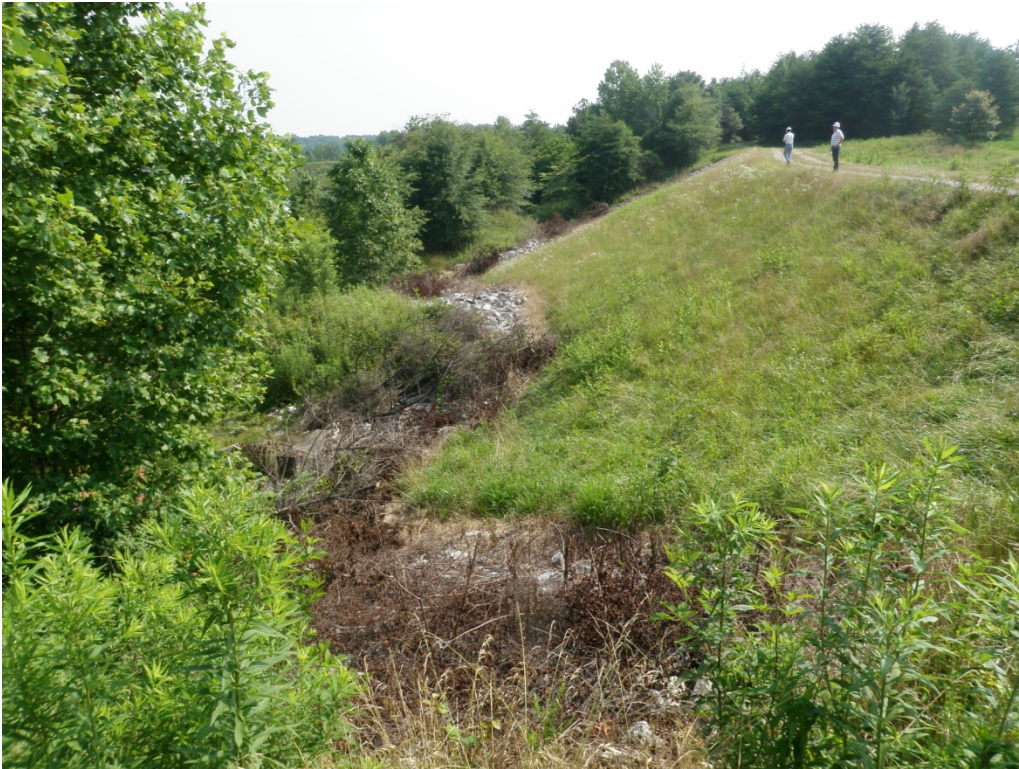
We observed no signs of movement, instability, or major deterioration on the divider dike. Slope protection consists of grass on both the upstream and downstream slopes, and riprap along the abutment contacts and downstream toe. The slope protection is in good condition.

Photo 21 –Divider Dike: Downstream slope.

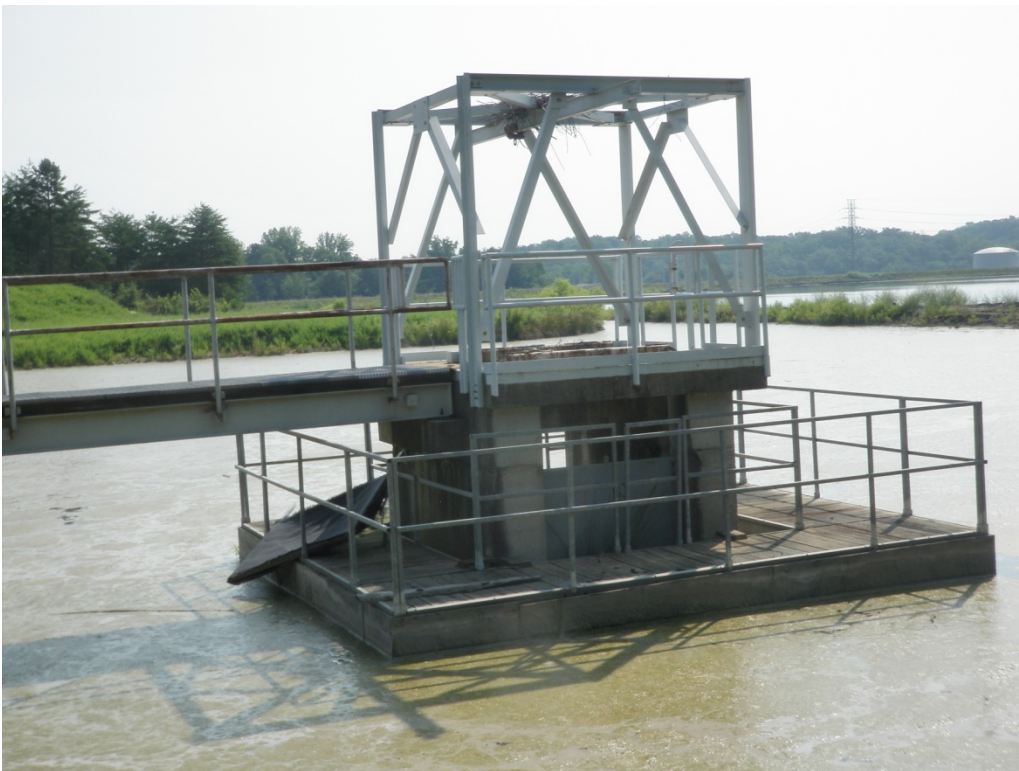
Photo 22 –Primary Active Ash Pond outlet structure.

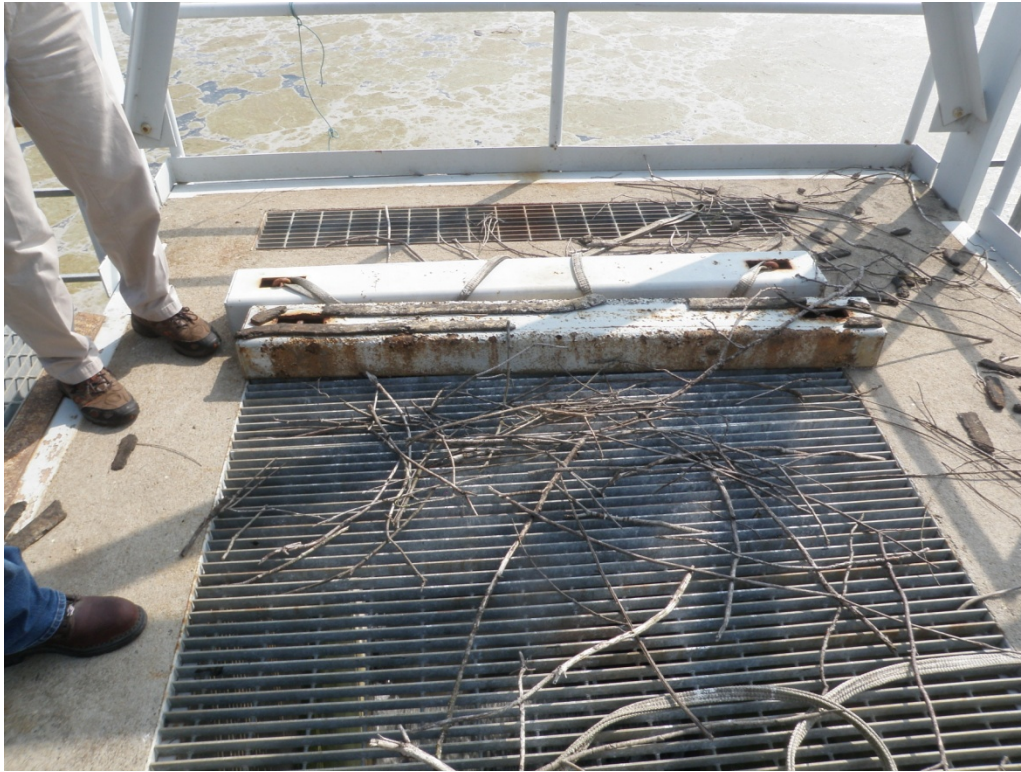
Photo 23 –Primary Active Ash Pond outlet structure – stop logs.

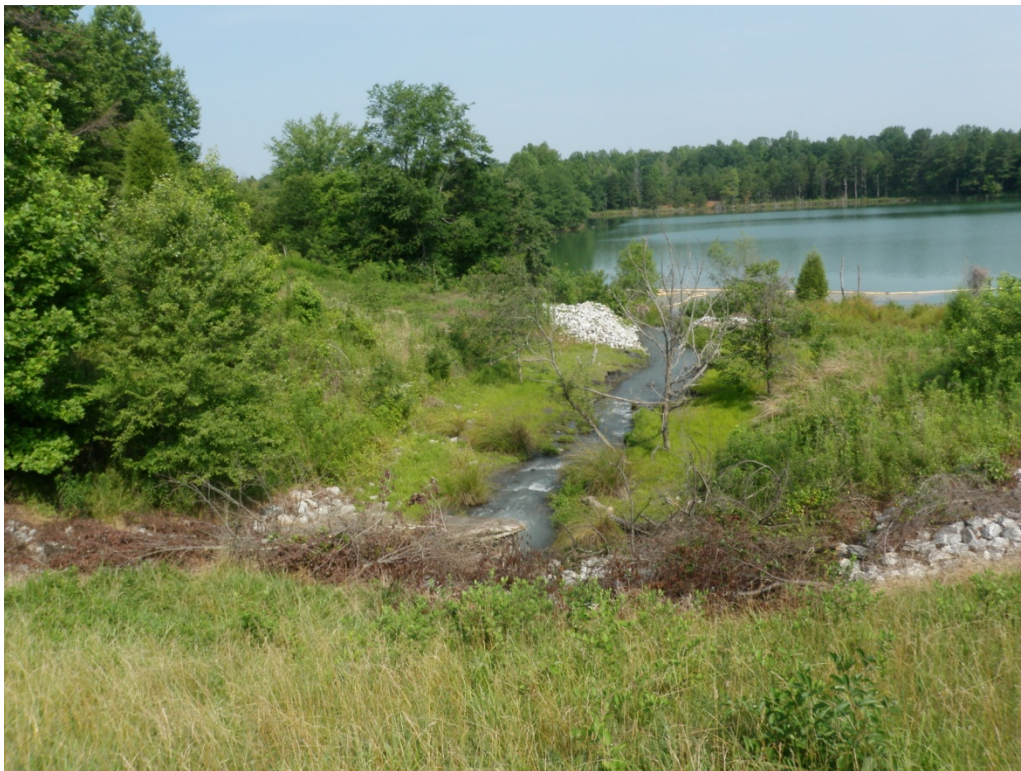
Photo 24 –Primary Active Ash Pond outlet structure – channel to Secondary Ash Basin.

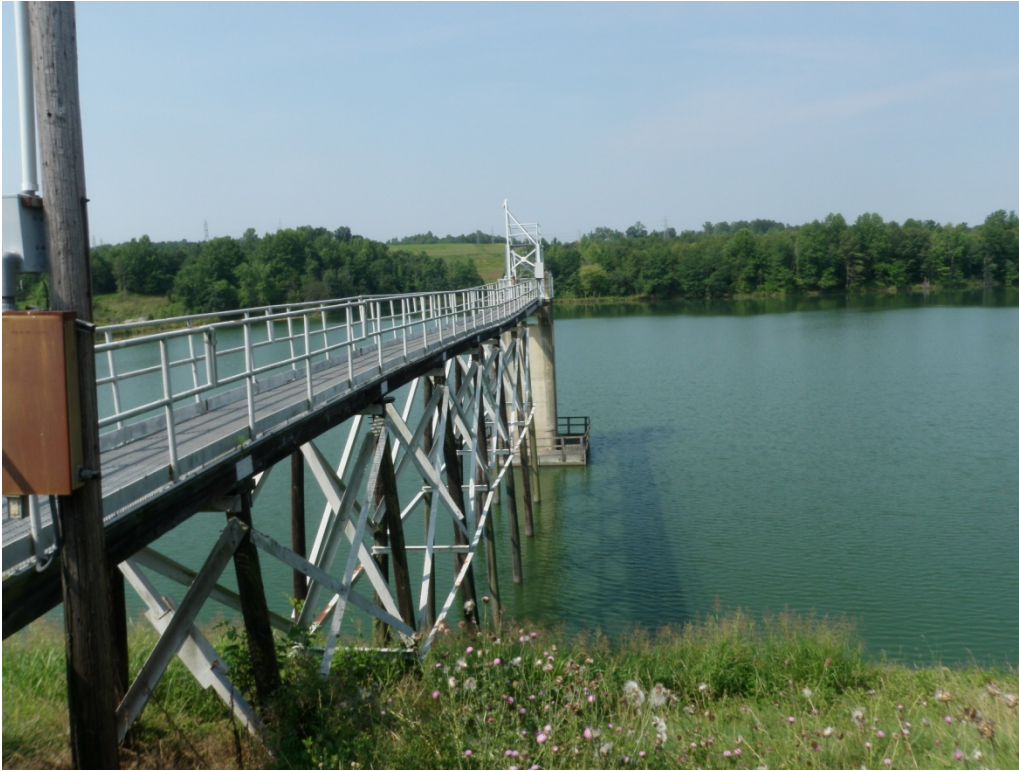
Photo 25 – Secondary Ash Basin outlet structure and bridge.

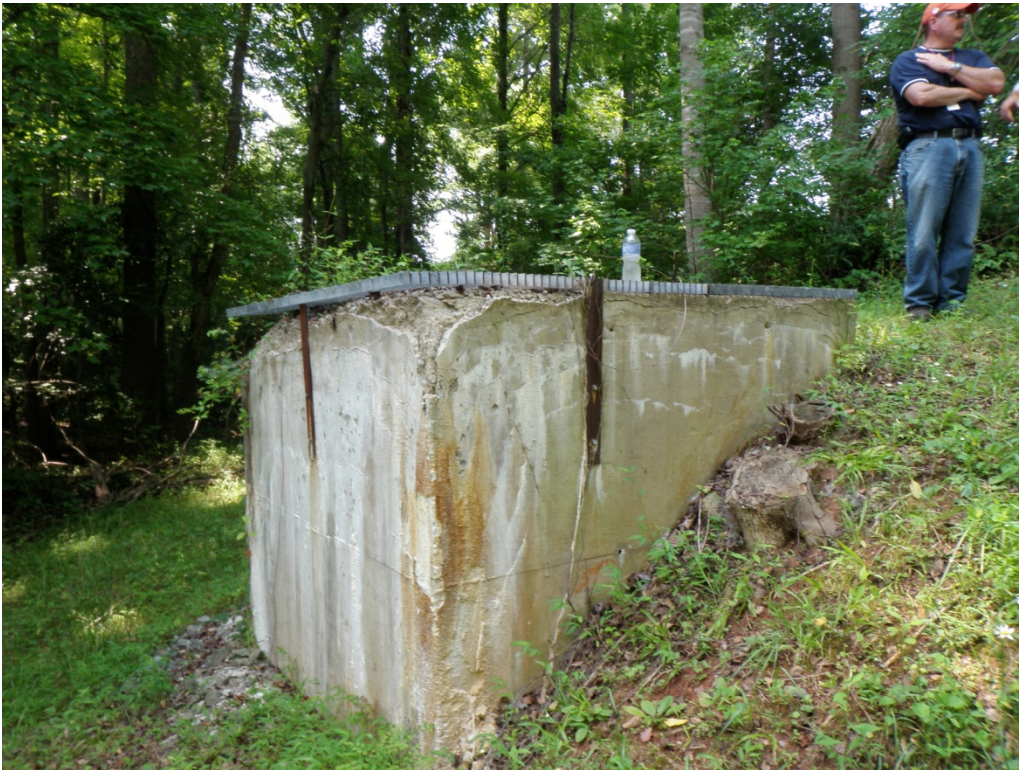
The outlet structures located in the CCW impoundments appeared to be in fair to good condition. The structures were observed to be working properly, discharging decant water downstream. Stop logs used to control the flow appeared to be functional, and the skimmers used to keep debris out of the pipes were in place. The outlet conduits consist of reinforced concrete pipe (RCP) and appear to be in good condition. The concrete drop box at the outlet for the Secondary Ash Basin exhibits some spalling on the edges. The inside of the drop box

may also be deteriorating, especially considering the turbulent flow of water inside the drop box.

The exterior of the drop box downstream of the Secondary Ash Basin exhibits some degradation. The inside of the box may also be degrading due to turbulent flow.

Photo 26 – Secondary Ash Basin outlet works – drop box downstream of dam. Note spalling.

6. The inside and outside of the drop box downstream of the Secondary Ash Basin should be monitored for continued degradation, and repaired or replaced if necessary.

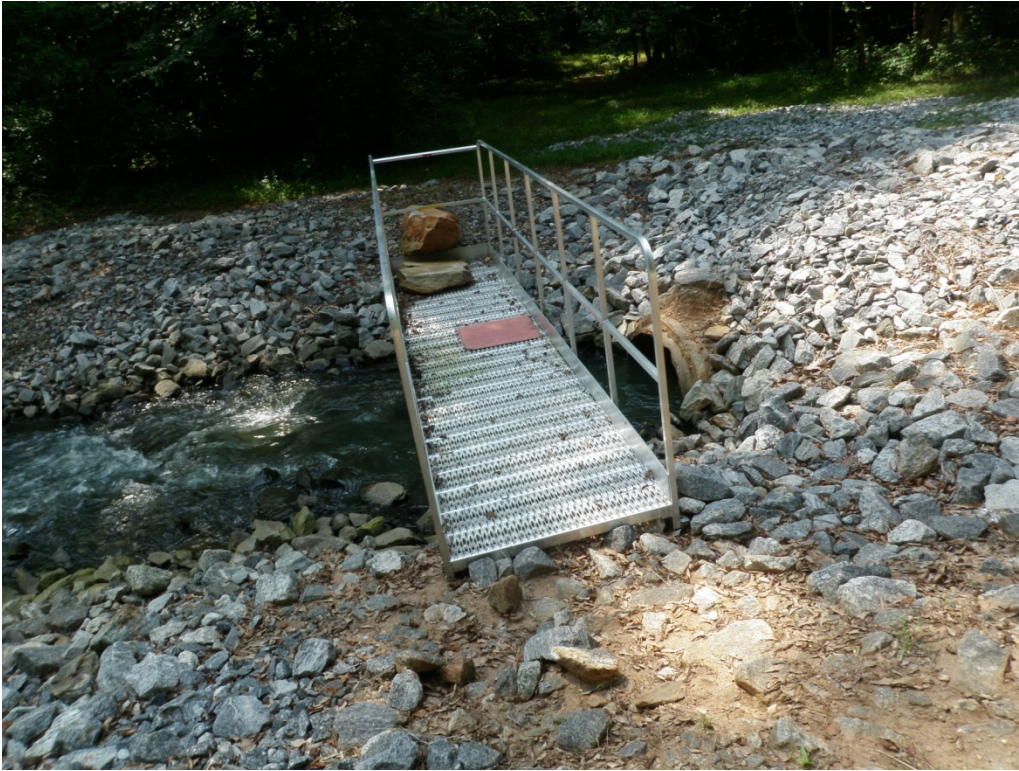
Photo 27 – Secondary Ash Basin outlet works – discharge conduit.
